Manhole Inspection Summary

Manhole # S15A1_008MH

Insp Date: **6/30/08 11:00 AM**

Location Address: **2831 georgetown rd**

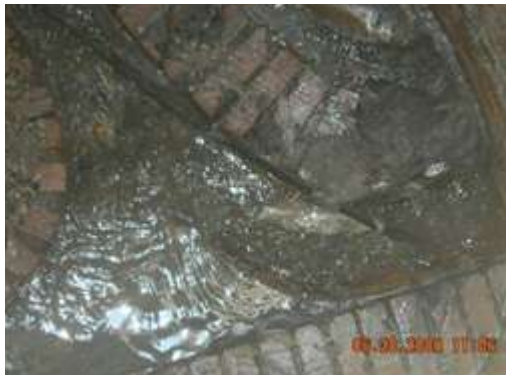
Defect 3

Condition: ☐ Sound ☐ Cracked ☐ Root Intrusion ☐ Deteriorated ☐ Leaks ☒ **Debris**

debris in channel

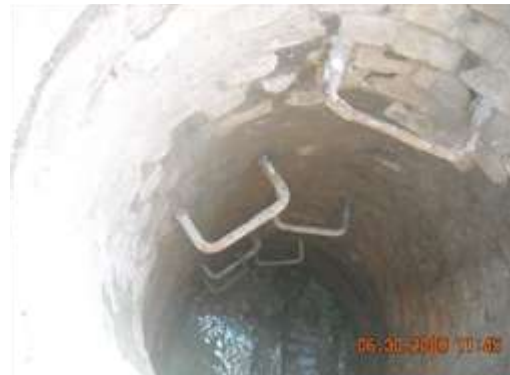
Defect 2

Infiltration: ☐ None ☒ **Joint** ☐ Cracks ☐ Mortar ☐ Roots ☐ Wall

Count: **6** Missing: **0** ☒ **Corroded**

corbel infiltration, corroded steps

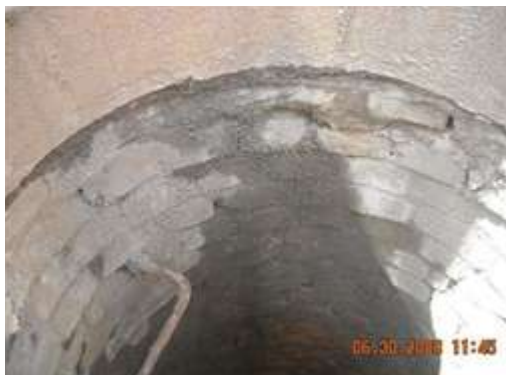
Defect 1

Infiltration: ☐ None ☒ **Joint** ☐ Cracks ☐ Mortar ☐ Roots ☒ **Wall**

chimney flow wall, joint

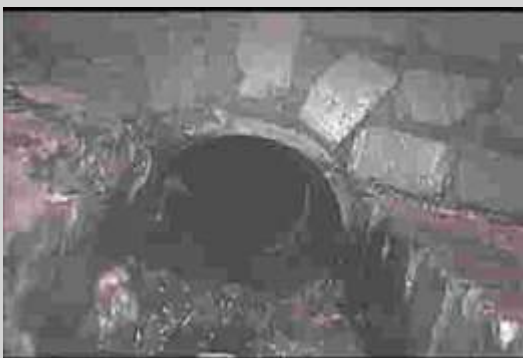
3 O'Clock Inflow

Pipe Height: **8.4** (in.) Rod and Bar (Angled)
Pipe Material: **Clay** ☐ Pipe Lined
Invert Depth: **11.25** (ft.) Flow Characteristics: **Fast**
Deposits: ☐ None ☐ Mud ☐ Sludge ☒ Debris ☒ Grease
Silt Depth: **3** (in.) Deposits Extent: **Medium**
Infiltration: **None** Pipe Seal Cond: **Sound**
